**UNDERWATER FACILITIES
INSPECTIONS
AND
ASSESSMENTS
AT

NAVAL WEAPONS STATION

CHARLESTON, SC**

FPO-1-81 (7)

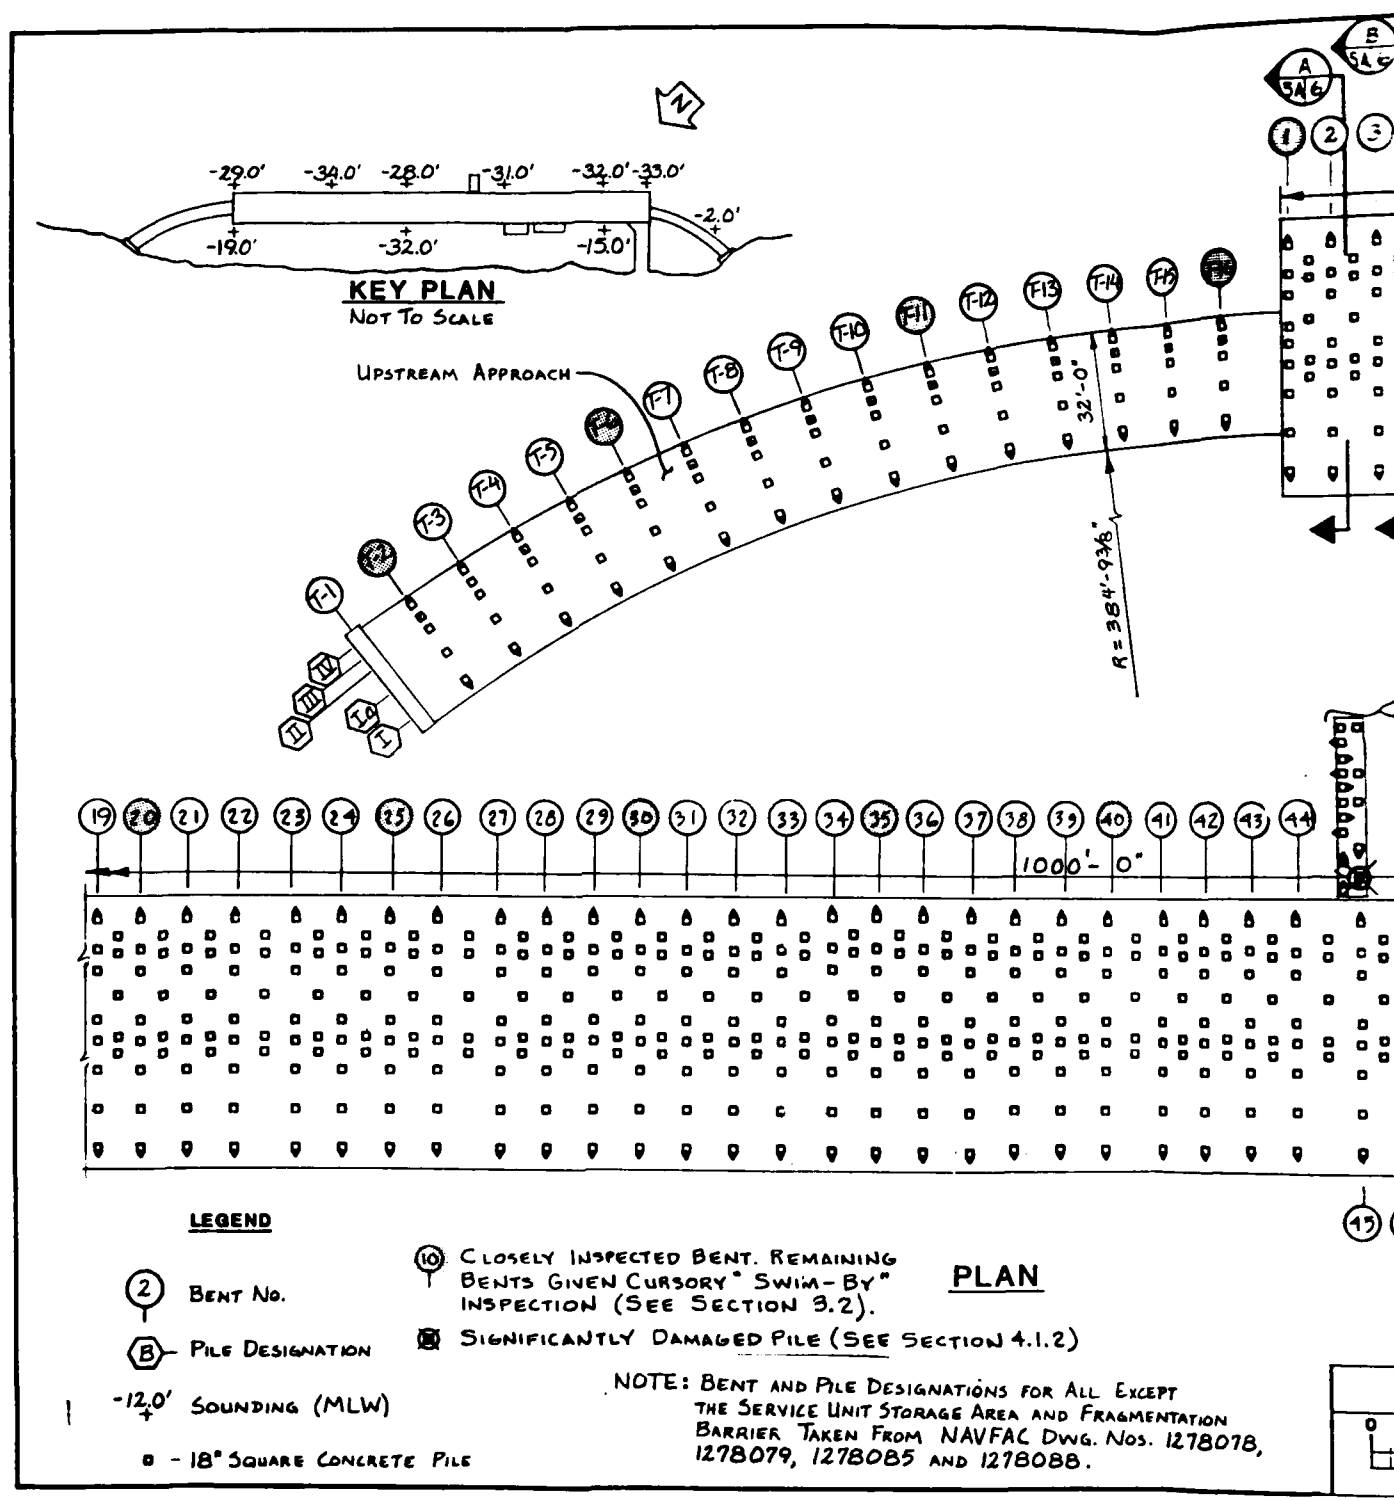
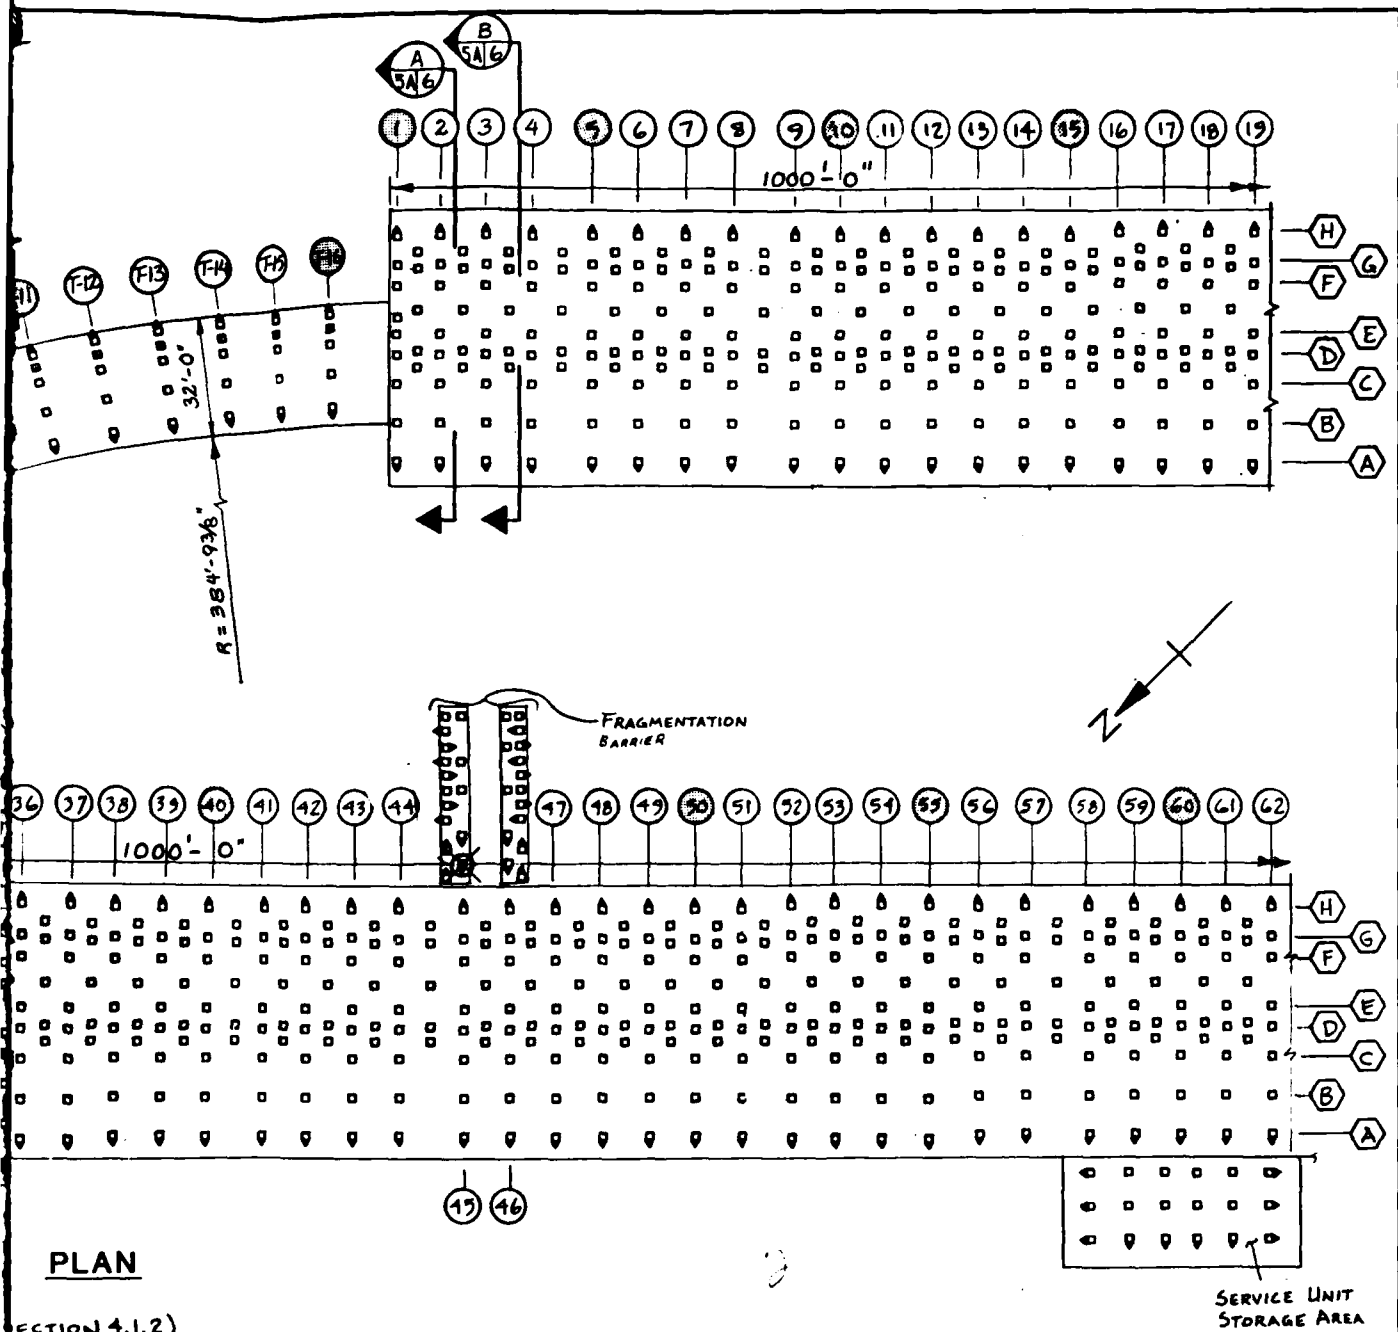
FIG. 5A

<u>Bent</u>	<u>Pile</u>	<u>Elevation (from MLW)</u>	<u>Description</u>
82	A	-2.0'	3" diameter spalled area; no steel reinforcing exposed.
65	B	0.0'	Spalled area, 7" long and a maximum of 2" deep; no steel reinforcing exposed.
Fragmentation Barrier (See Figure 5)		-7.0'	18" high x 6" wide by a maximum of 2" deep spalled area; no steel reinforcing exposed.

Soundings taken at Wharf ALPHA can be seen in Figure 5. These soundings showed depths ranging from -28.0' to -34.0' below mean low water (MLW) along the outshore face of the main wharf area.
